# CERTIFICATE

(Certificate of conformity with technical requirements in: ) API STANDARD 607 Eighth Edition, October 2022

Certificate No.:296204

(Valve Fire Test According to API STANDARD 607 Eighth Edition, October 2022.)

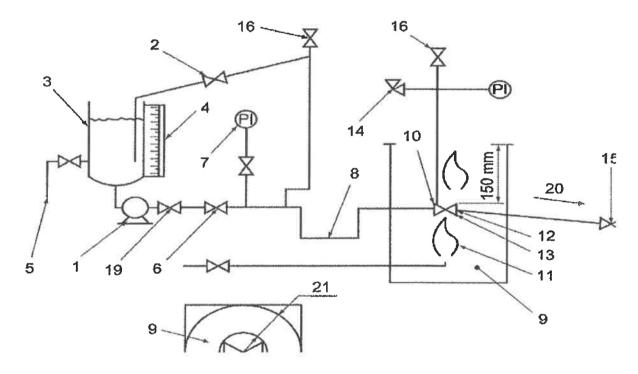
Figure 1. Typical Fire-Test System Using a Pump as the Pressure Source

The test equipment was verified by TÜV SÜD inspector according to requirements of API STANDARD607 Eighth Edition, October 2022. Para.5.3 and found satisfactory. The detail arrangement of the fire-test equipment is shown below:

- 6. Preparation before testing:
- 6.1 The thermocouples and calorimeters were installed properly according to Figure 1,2,3,4 in API 607. Two thermocouples (part 13) are installed to measure flame temperature, one is located under valve body, another is located under valve stem, both within 1". Two calorimeters (part 12) are positioned to the same place as the thermocouples do.

- 6.2 The test system including test valve (part 10) was cleaned through by water before testing. All air was purged from test valve and testing system by water.
